**GENERAL MOTORS LLC IGNITION  
SWITCH LITIGATION**

**COMPLAINT AND JURY TRIAL DEMAND**

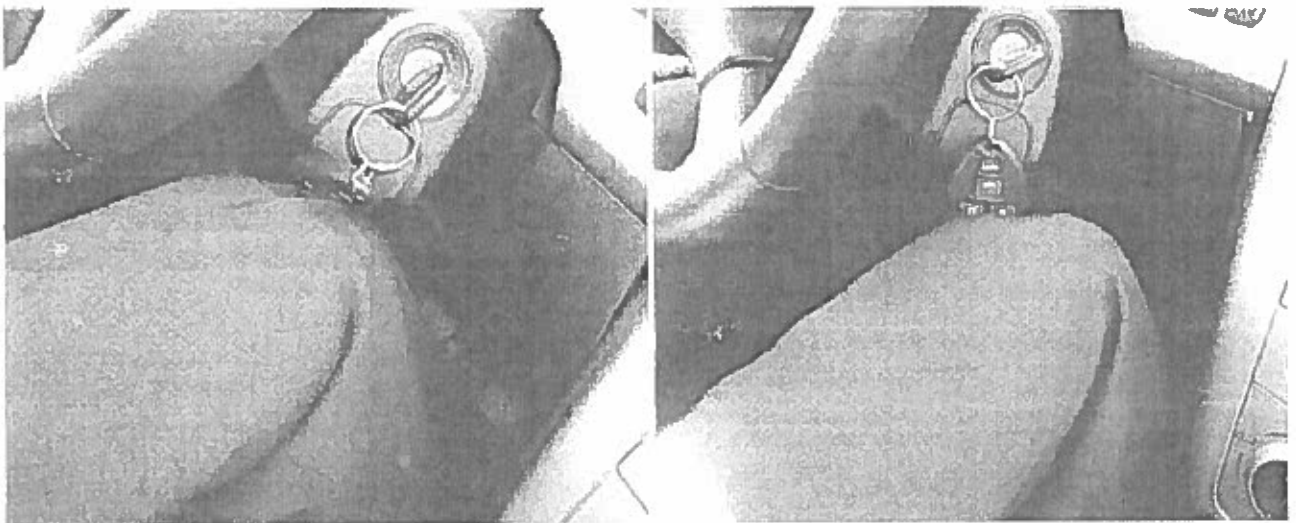
64. The photographs below depict a GM engineer in the driver's seat of a Cobalt during the investigation of Cobalt stalling incidents. Note the proximity of the driver's knee to the ignition key:

These photographs show the dangerous position of the key in the lock module on the steering column, as well as the key with the slotted head, which allows the key fob to hang too low off the steering column. GM engineers understood that the key fob can be impacted and pinched between the driver's knee and the steering column, and that this

may cause the key to inadvertently turn from the “run” to the “accessory” or “off” position. The photographs show why GM engineers understood that increasing the detent in the ignition switch would not be a total solution to the problem, for such a step would not alleviate the possibility of impacting the key with a driver’s knee. The photographs also show why GM engineers believed that additional changes (such as the shroud) were necessary to fully fix the defects with the ignition switch.

63. Indeed, GM engineers identified several additional ways to actually fix the problem. Unsurprisingly, these solutions echoed solutions that Old GM engineers had proposed years before, but had decided not to implement because of cost concerns. GM engineers proposed adding a shroud to prevent a driver's knee from contacting the key, modifying the key and lock cylinder to orient the key in an upward facing orientation when in the "run" position, and adding a push button to the lock cylinder to prevent it from slipping out of run. GM rejected each of these ideas.
